## Qualitative Infrared Thermographic Survey of Electrical Switchgear

*Prepared for:*  
**Mr. Sample Client**  
**Acme Widget Company**  
9274 Industrial Drive  
Your Town, Your State 23456

June 4, 2011

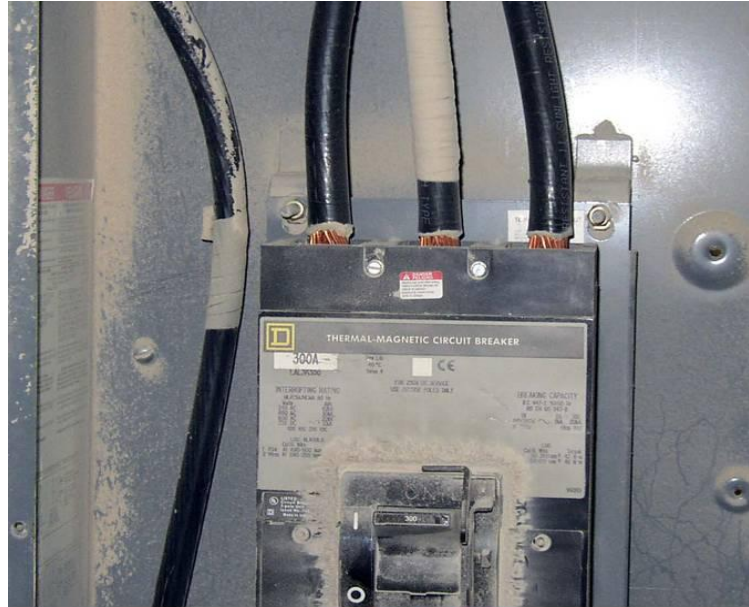
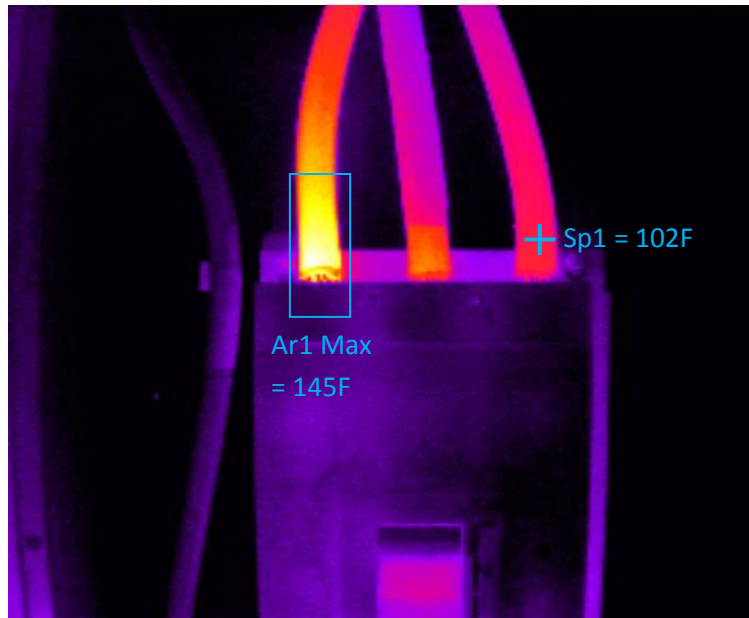
# THERMOGRAPHIC REPORT # 1

**AREA:** MSR/MAIN PANEL  
**LOCATION:** Main  
Disc/MCC-1

Ar1 = 145 °F

**Fault Rating = Serious**

Temperature Rise: 43°F

**DESCRIPTION:** Breaker Lug, Phase A, Line side is overheating.

**RECOMMENDATION:** Check Lug Connection
